# CODE REQUIREMENTS AND BEST PRACTICES: HYDROGEN

***Updated October 2019***

**Frontier Energy**

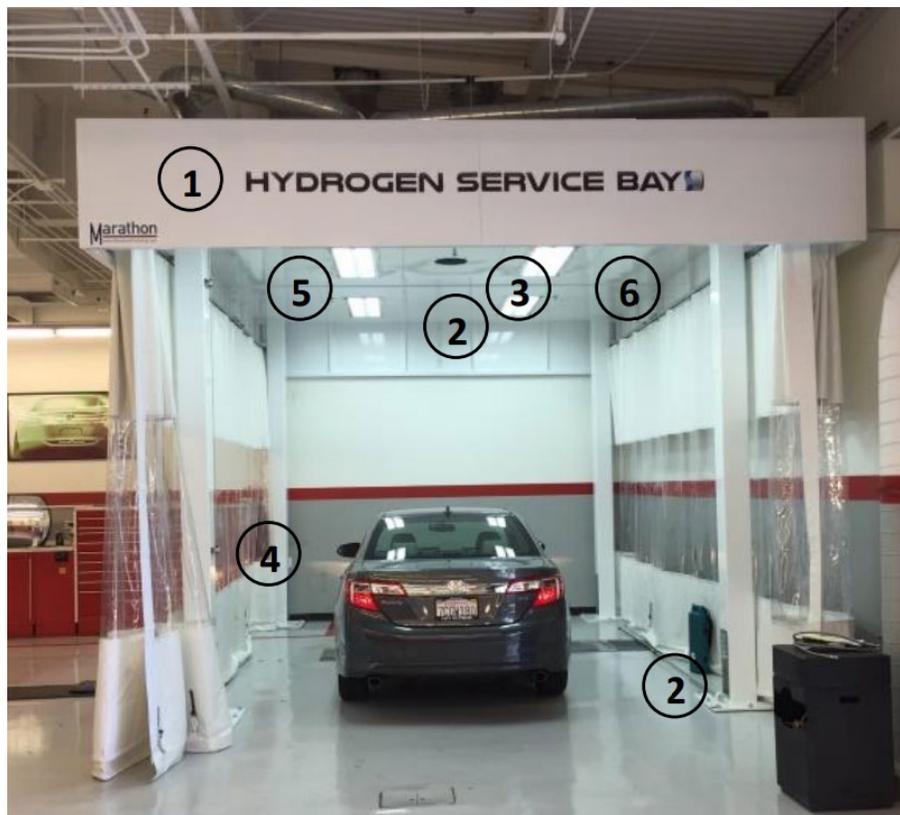
1. Enclosed space:
  - a. Freestanding hood / valence supported by 4 posts
  - b. Retractable vinyl curtains (NFPA 701 fire retardant)

2. Ventilation system with exhaust at ceiling and with make-up air intakes at lower 4 corners
3. Hydrogen sensing with audible and visual alarms
4. Atmospheric hydrogen defueling system coupling
5. Classified electrical appliances within 18" of ceiling (NFPA 30A compliant)
  - a. Above ground lift requires Class I, Division 2 limit switch or switch must be located outside of upper 18" zone
  - b. Overhead lights; sealed, tempered glass (Class I, Division 2)
6. Fire sprinklers

One strategy for code compliance in a major hydrogen garage is the Hydrogen Service Bay, a product offered by Marathon Finishing Systems. The service bay separates the bulk of a garage volume into an encapsulated service environment through the use fire retardant, retractable vinyl curtains. Each bay is vented independently, with designated air intake and exhaust. For minor repairs, not all features typically included are required by code, but many installations that utilize this system were designed with an abundance of caution.
